## **Preparation of molds for rubber molding to ensure smooth start-up in production**

*By George Barton, Chem-Trend Limited Partnership, April 14, 2006*

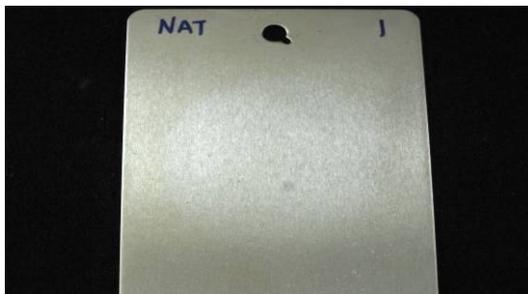
Immediately after coating

Here are photos of the panels used for natural rubber molding, coated with the anti-moisture barrier

Although one can quite clearly see the disc where the molded rubber has been in contact with the panel, there is no visible difference in the surface appearance of the two panels. The anti-moisture barrier has, indeed, been very effective in preventing the two things that cause corrosion, oxygen and moisture, from attacking the metal surface.
